Wallingford

Mountain Bike Association

INTERIM REPORT 7-28-04

Trail Progress

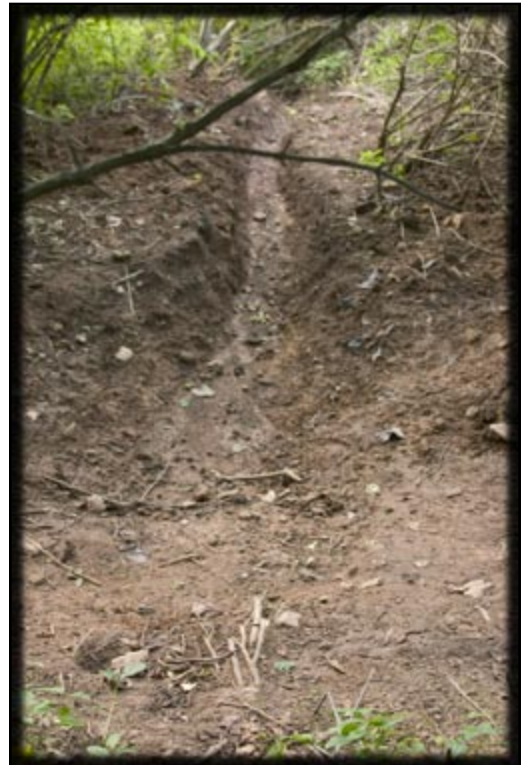
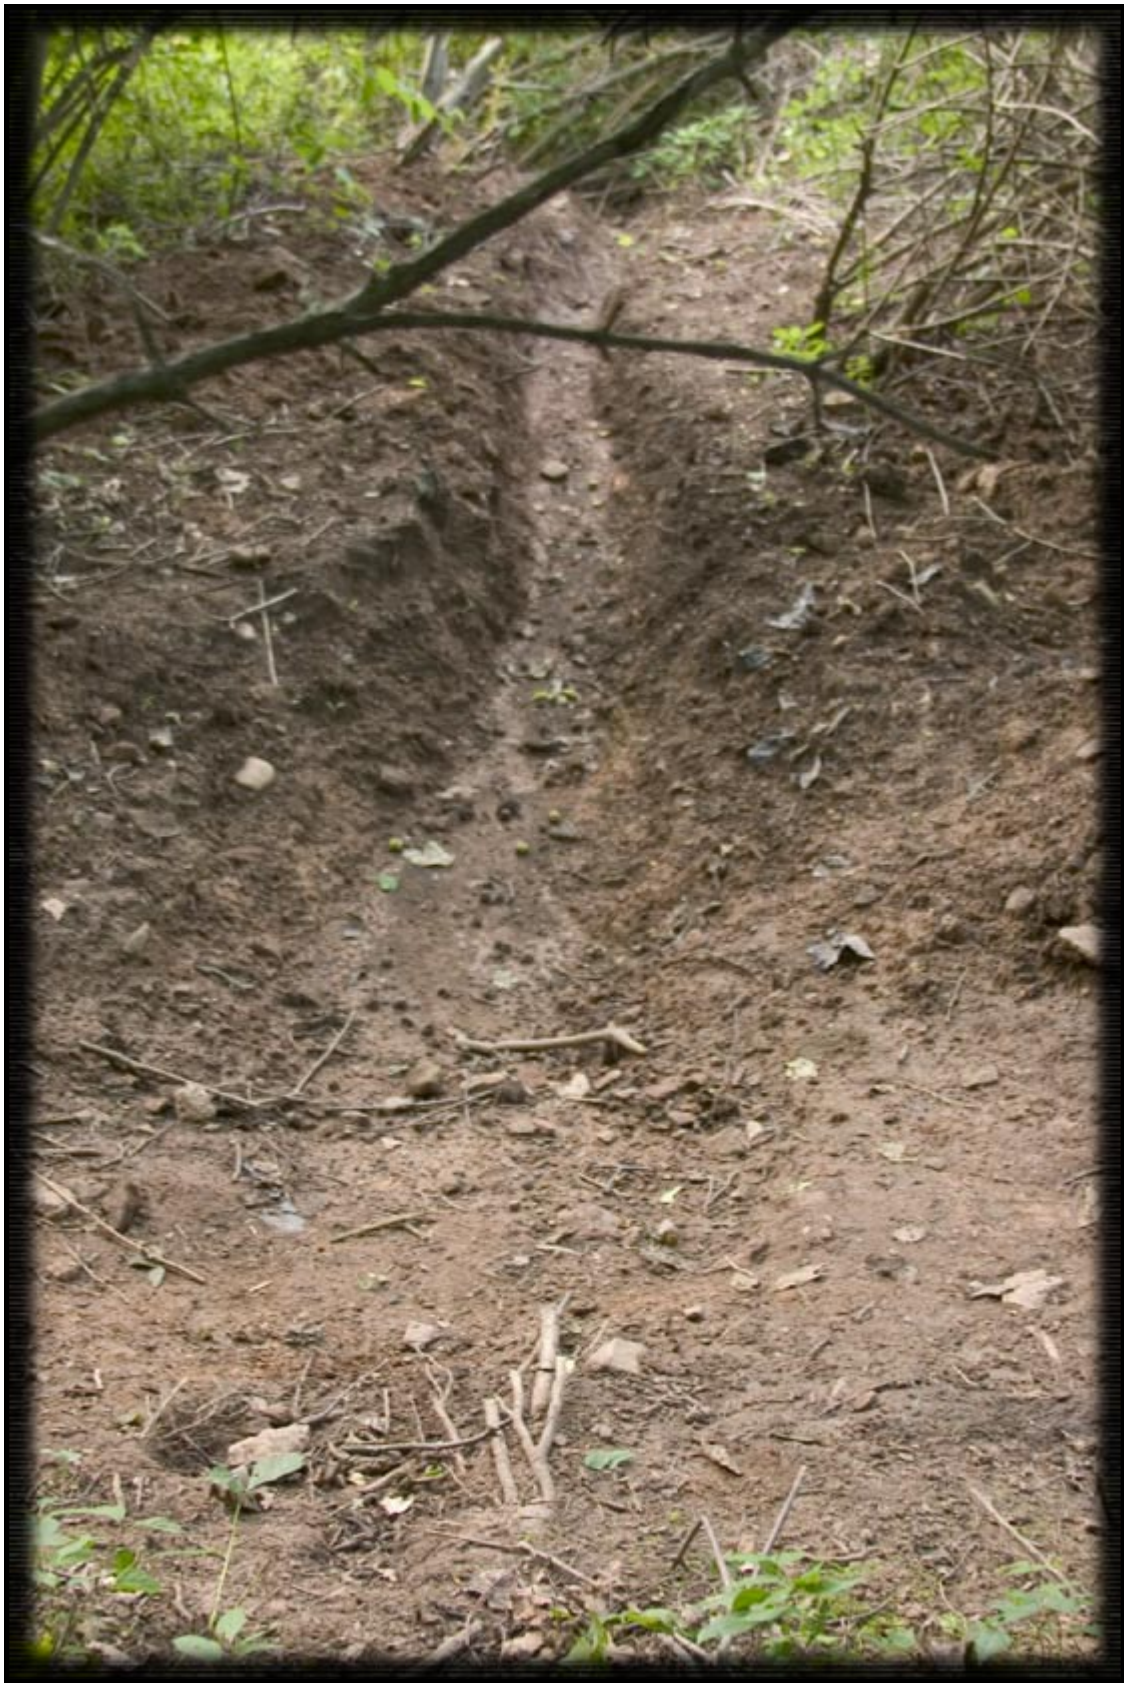
figure #1a

1. Two drainage ditches were dug in an area is notoriously muddy during the spring. The uphill trail to the south catches and retains the naturally flowing water going down to the vernal pool located on the northern borders of the soccer field. These ditches will increase the available amount of water for the vernal pool, ensuring that it does not dry up prematurely, which would kill wildlife dependant on standing water. Mud should be minimized for hikers and bikers using the trail, which can often get inadvertently widened by users trying to avoid the mud. (see figure #1a)

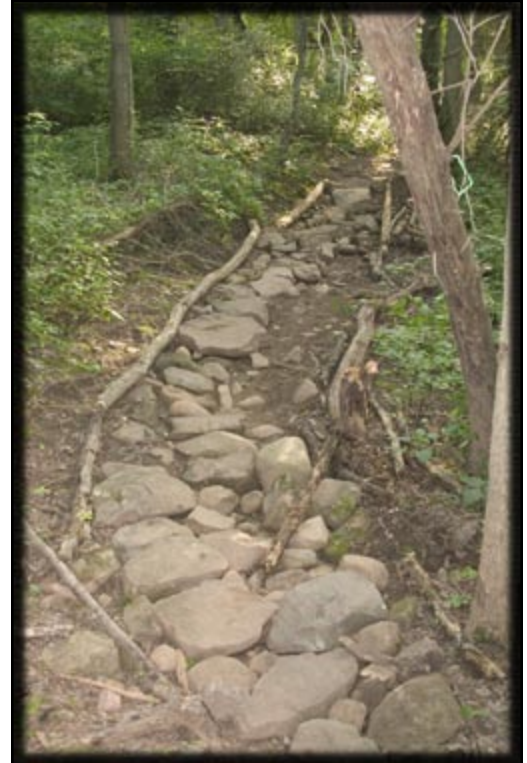
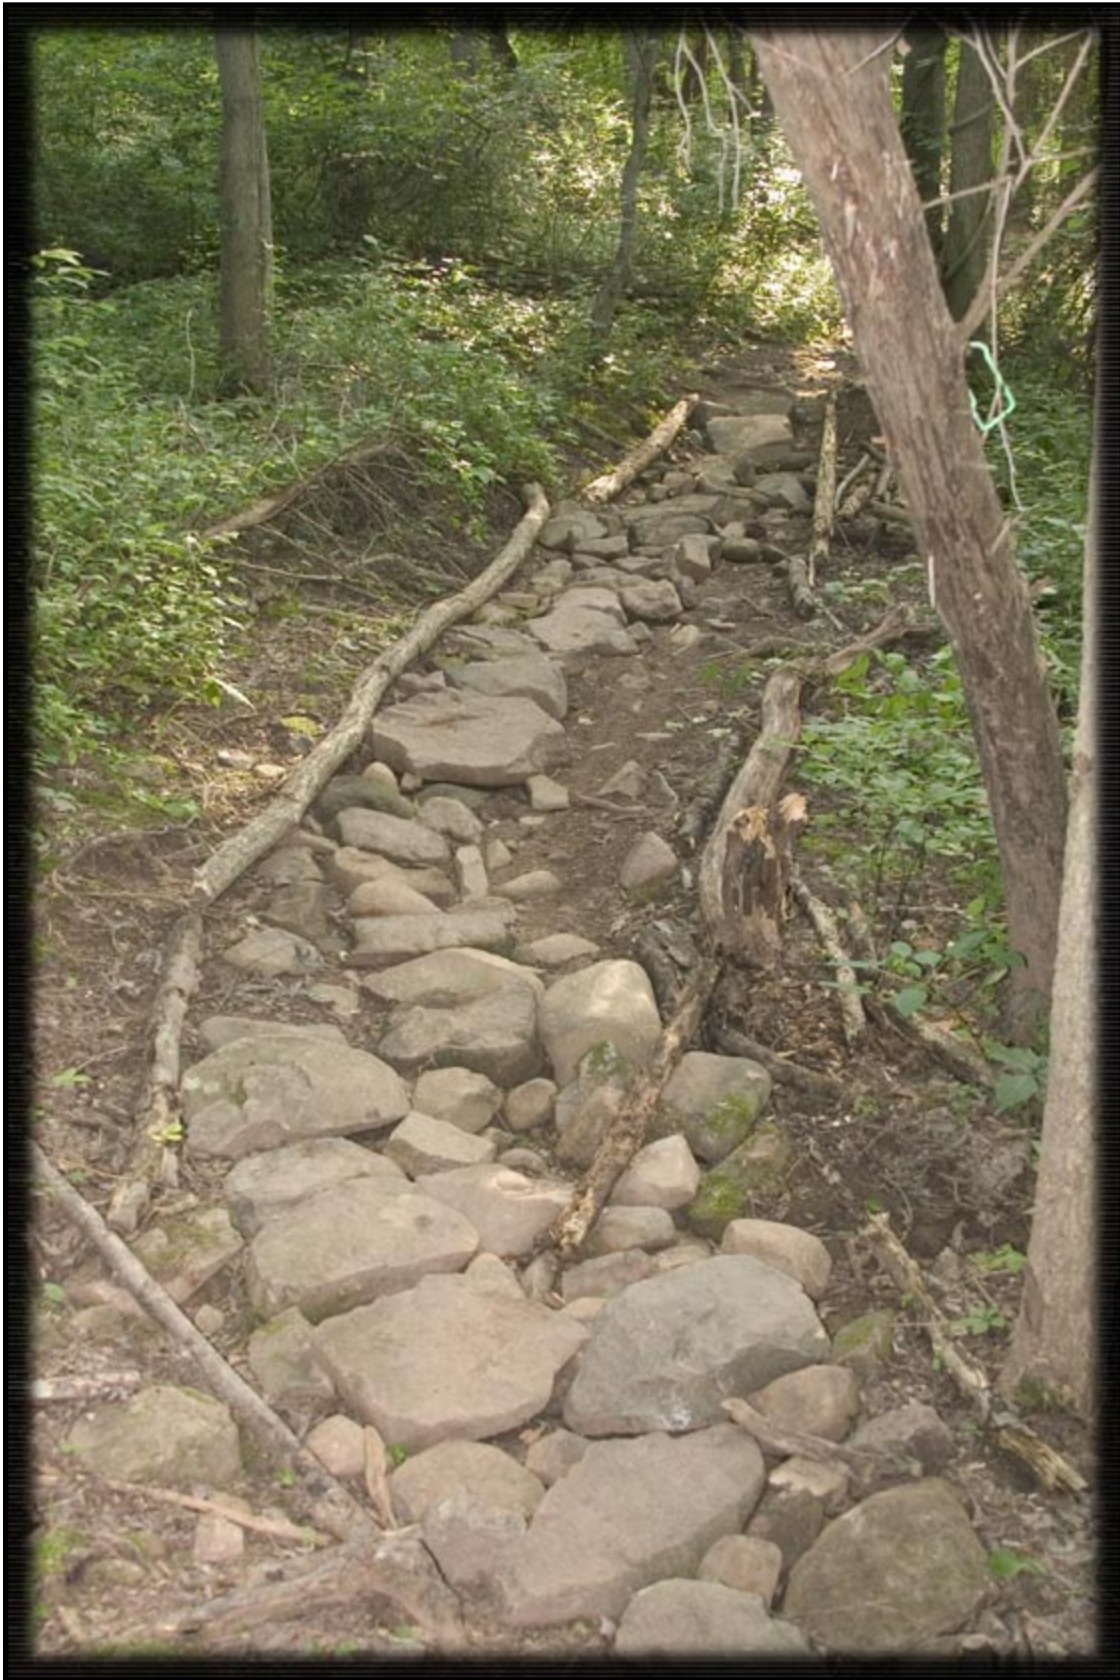
6. This is an example of “armoring” a trail. Rocks were gathered and put in the middle of a trail through a muddy area. Prior to the “armoring of the trail, this area was extremely muddy and was leading to trail widening. Armoring can be done with rocks (the first section) or with logs (the second section). Also, the route of this trail was rerouted to the south avoid a swampy area. The old section is very hard to see now (things grow very quickly in Tyler Mill), but if you can make out the trail, you see that it was close to a swampy area. (see figure #6a & 6b)

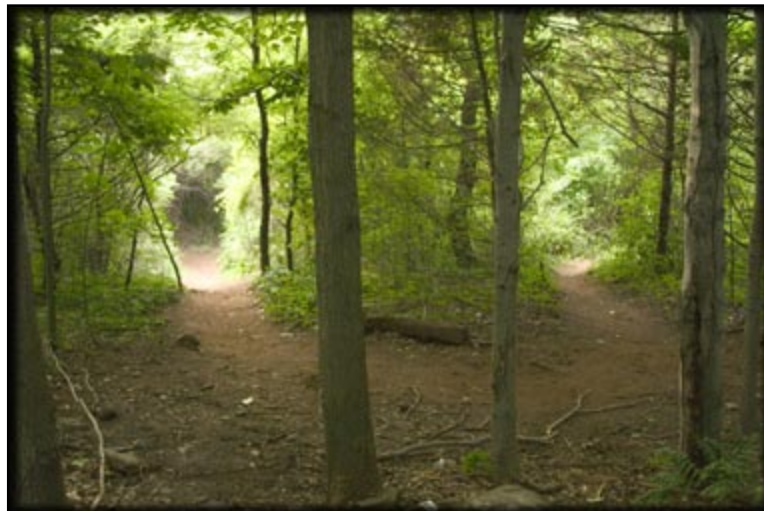
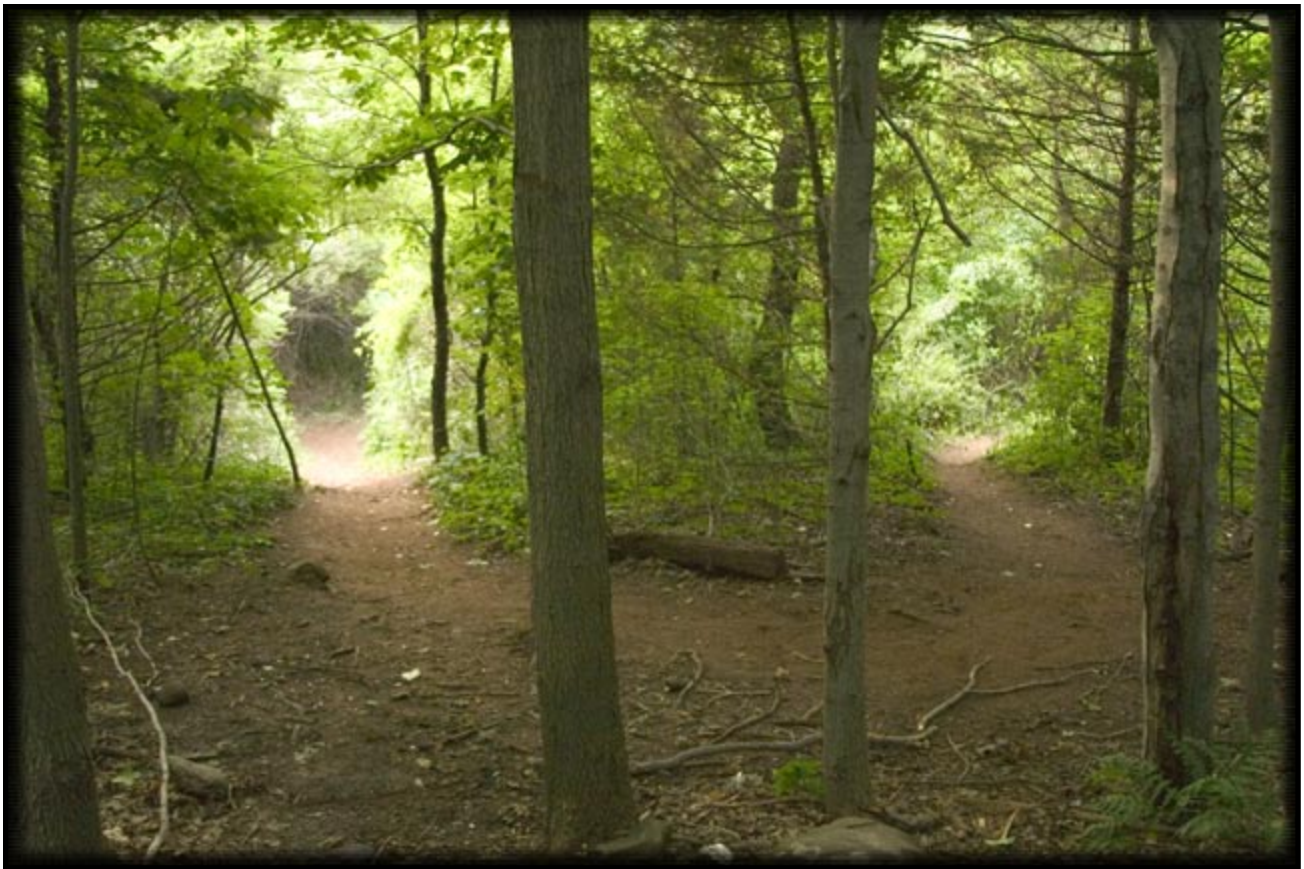
figure #13a

13. The second half to the maze begins where the trail reaches the road. This area is deliberately not trimmed during the spring to as to discourage its use as it is too wet to ride in there. (see *figure #13a*)

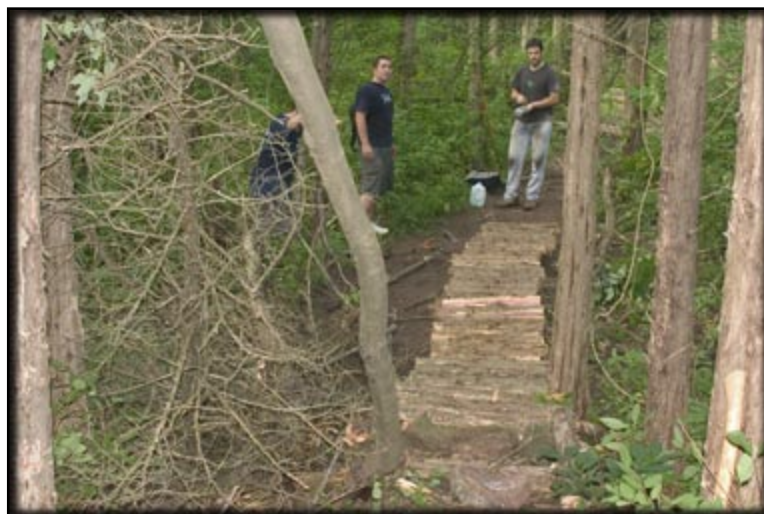
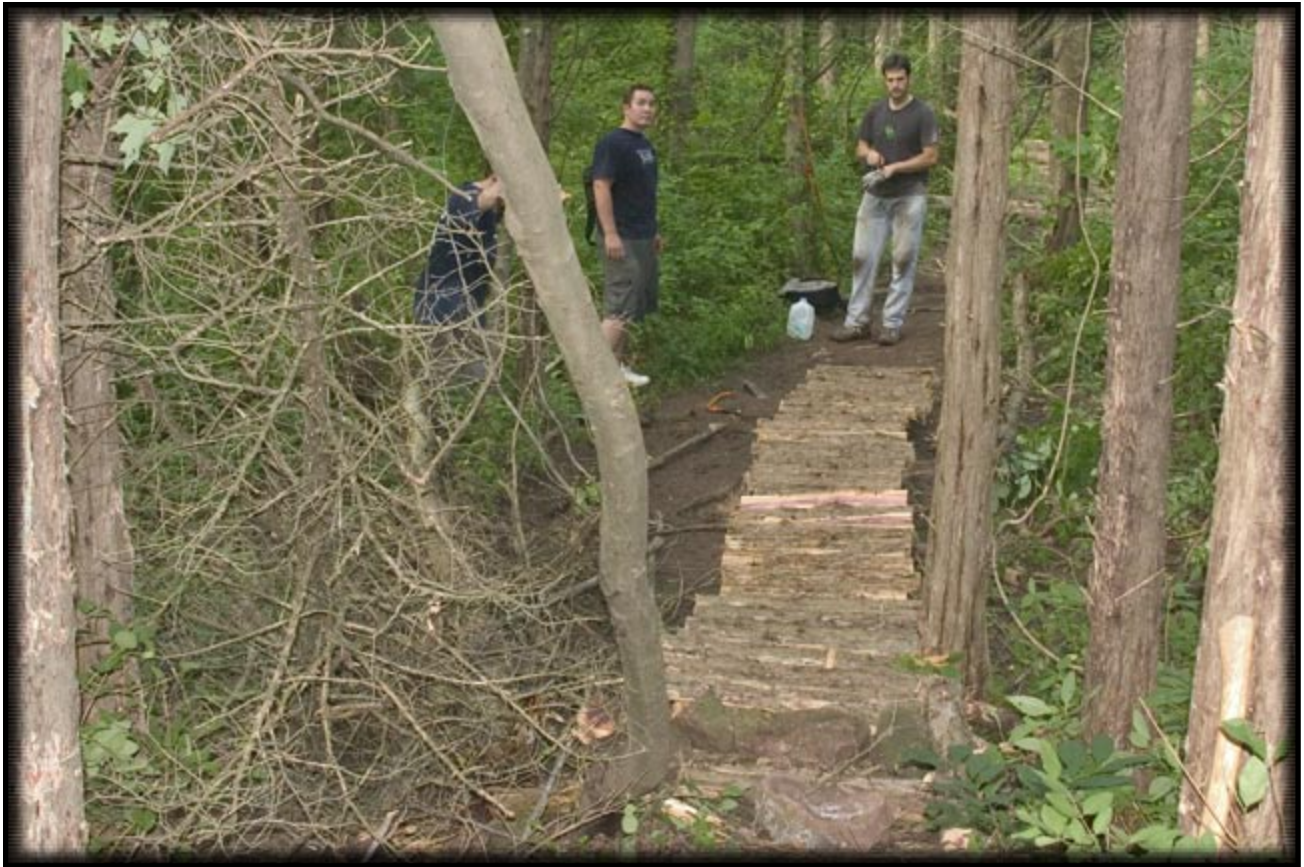
figure #18a

18. A log bridge was built over a muddy section. (see *figure #18a*)

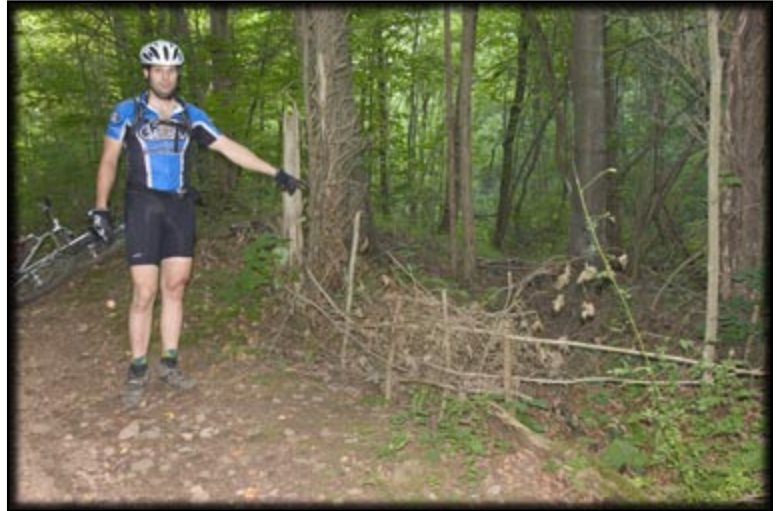
figure #20a

20. This is an experimental ATV fence built from all natural materials. Our strategy behind deterring ATV use is based on some of our own observations.:

- (1)** ATV users don't like getting off their machine's to move objects to access trails.
- (2)** They will create an alternative line to access a trail without getting off their ATV based on observed skid markings.
- (3)** Tyler Mill is an attractive area only for local residents as it is a very small parcel for ATV riding. Our strategy was to make it more difficult to access trails, although not impossible (if an obstacle was impossible to remove, ATV riders would do more damage creating a new trail in which access the trail system).

The ATV fences we built can be taken down by hand, but it takes some work. Running over the fences with an ATV does not work, so we hope the labor intensive destruction of the ATV fences will discourage those illegal trail users. The WMBA members have been monitoring the fences over the summer and immediately repaired damage when it is observed. Some early summer damage by ATVs was done to the fences, but finally the efforts have paid off. In the last 5 weeks, with only one exception, the trails have been remarkably ATV-free.

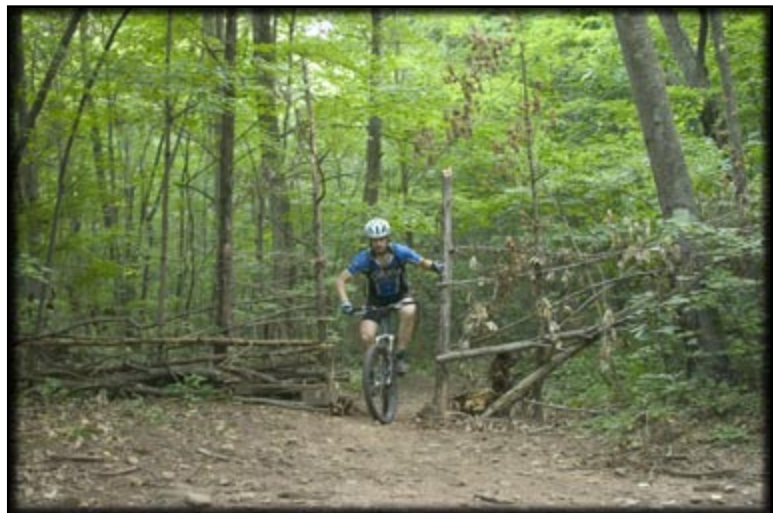
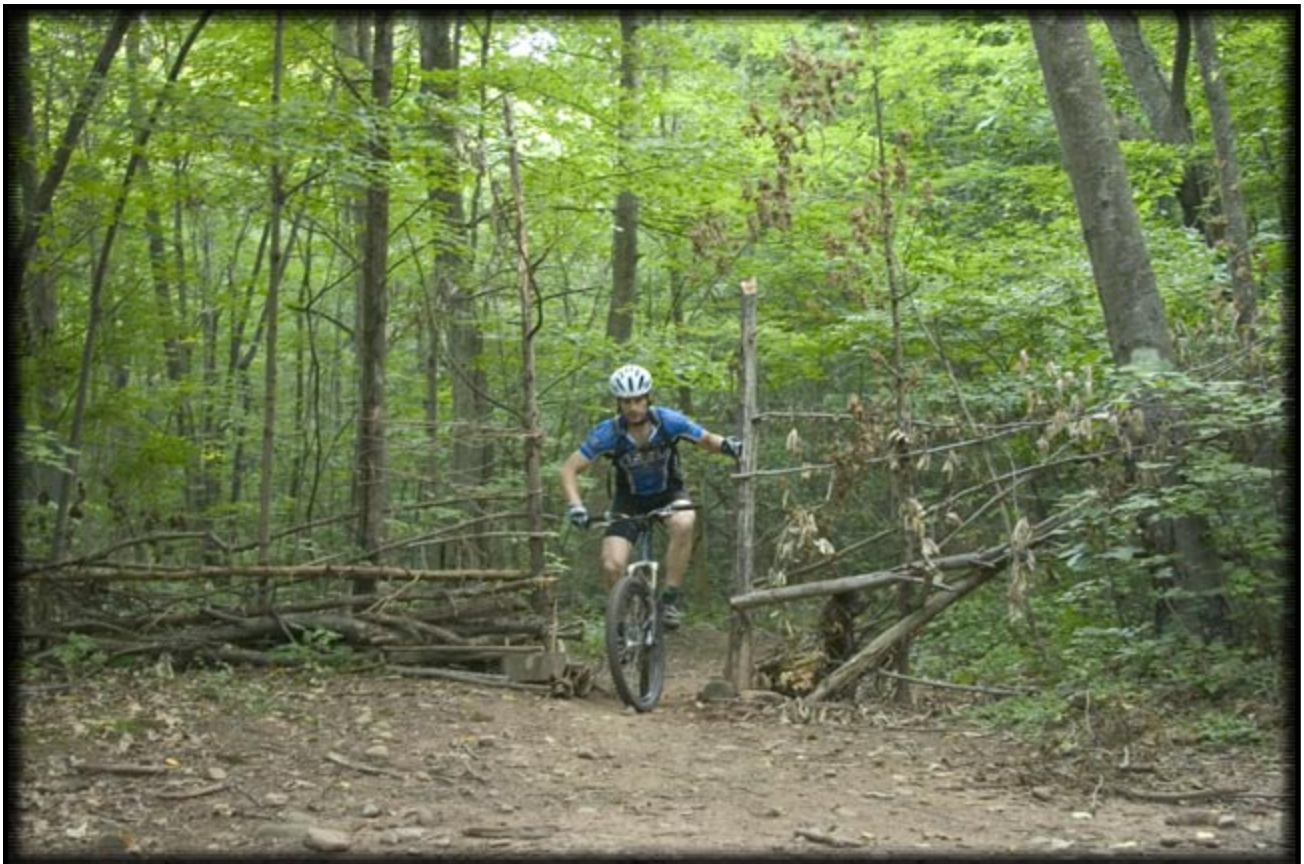
figure #22a

22. Another ATV fence. This one and Number 20 effectively cut off the entire west side of the area to ATV's. (see *figure #22a*)

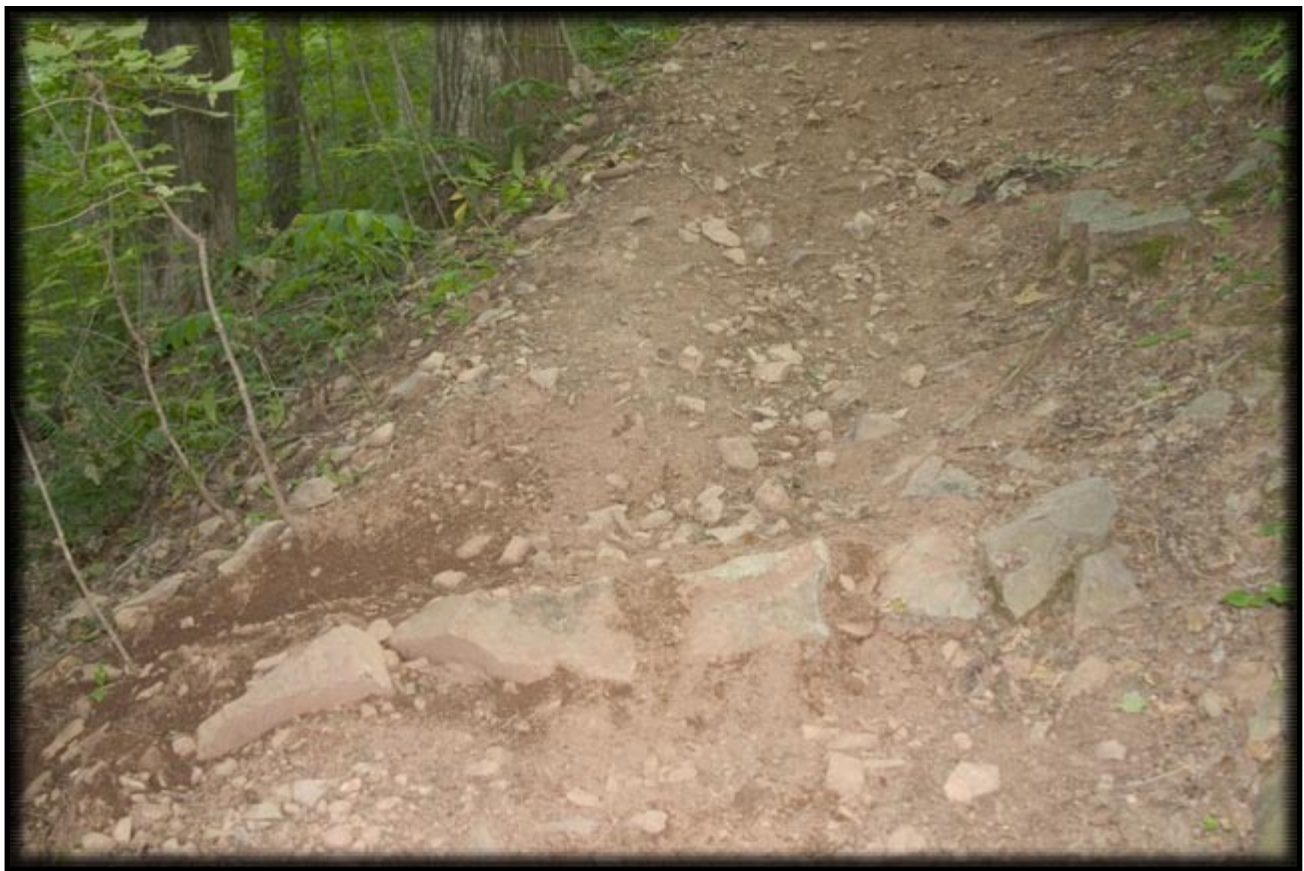
figure #2a

2. This water bar slows the rush of downhill water and diverts from the trail, allowing the trail to drain quicker and be more resistant to rutting out. Water bars can reduce the particulate matter that enters the watershed during heavy rains, which benefit aquatic life. (see figure #2a)

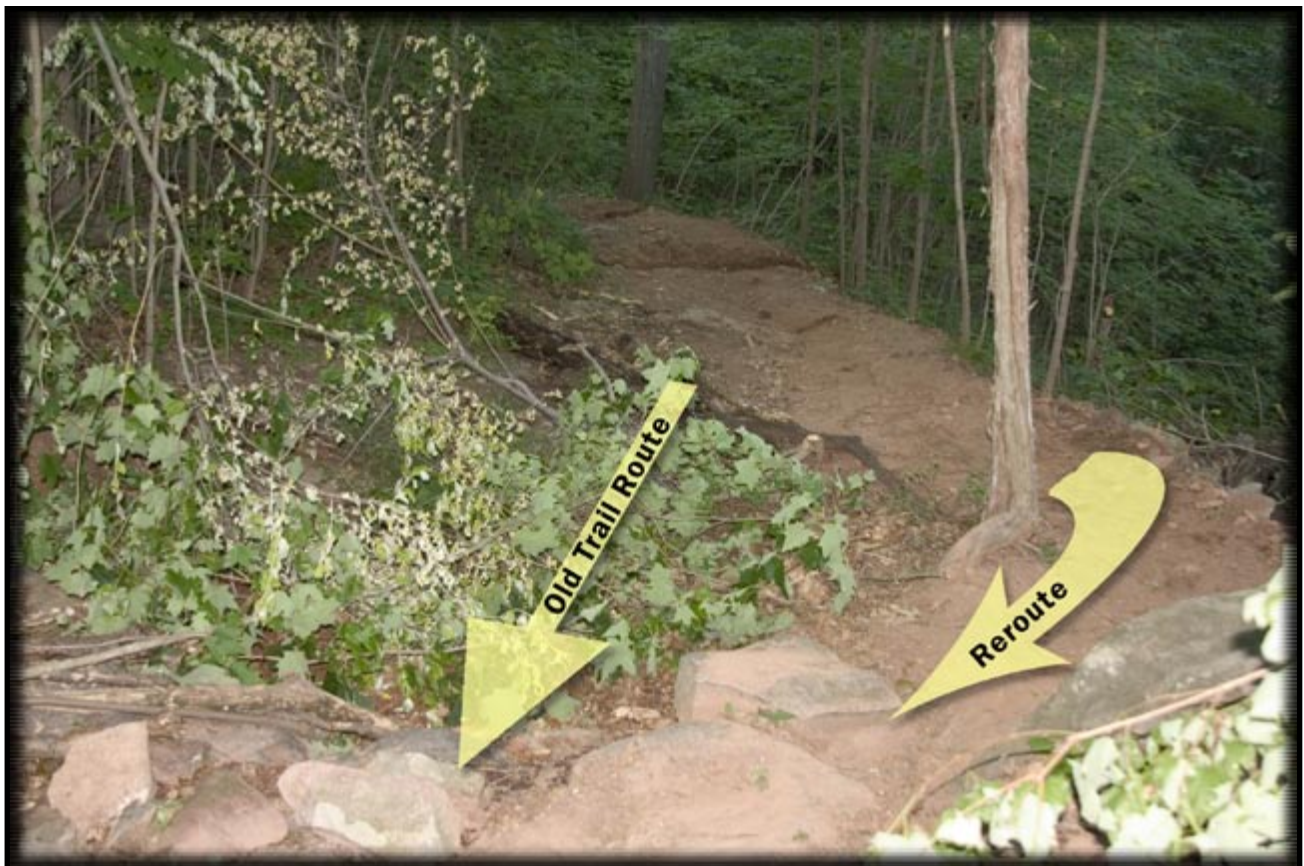
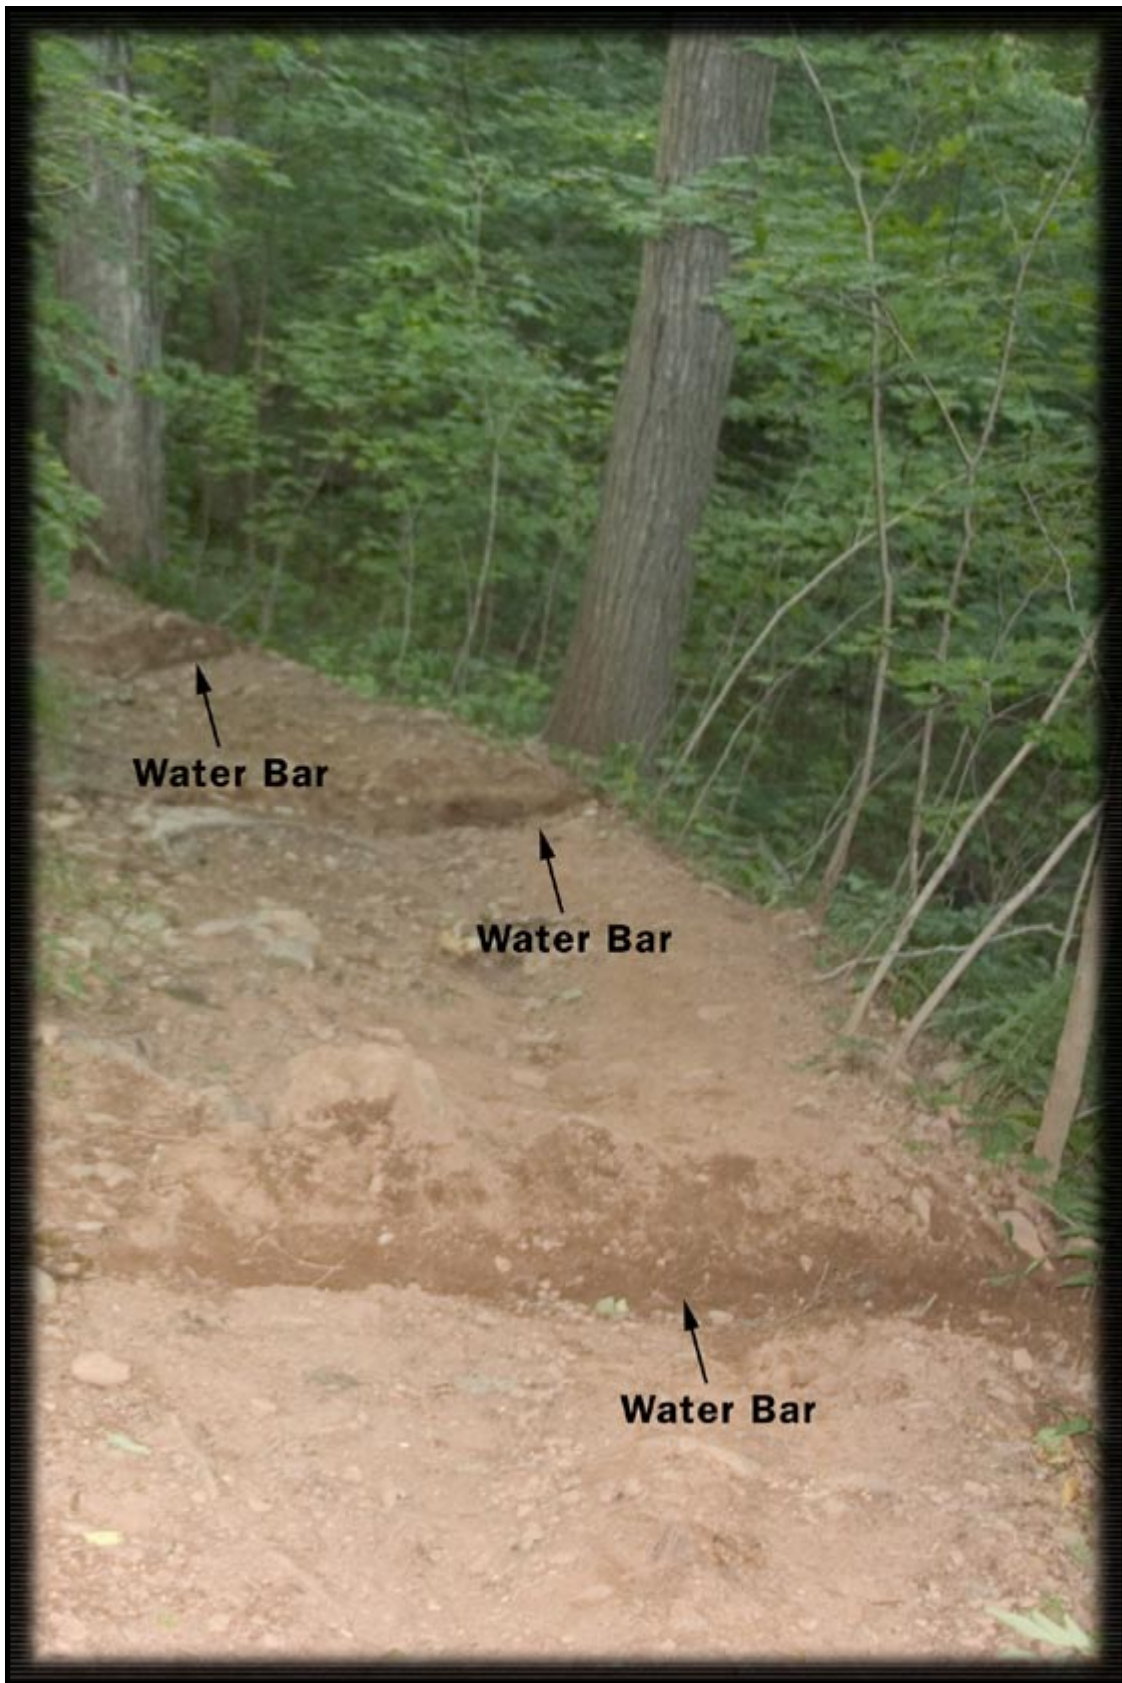
figure #3a

3. This hill is very steep and is of special concern due to some serious erosion. This group would like to see the trail rerouted completely as a future project if approved by Henry McCully. A reroute would lessen the grade, create switchbacks and allow this weak link in the trail system to sustain user traffic. As an interim measure, three water bars were added, and the trail was moved over a couple of feet at the top, as the previous location was impassable and was quickly eroding. (see figure #s 3a, & 3b)

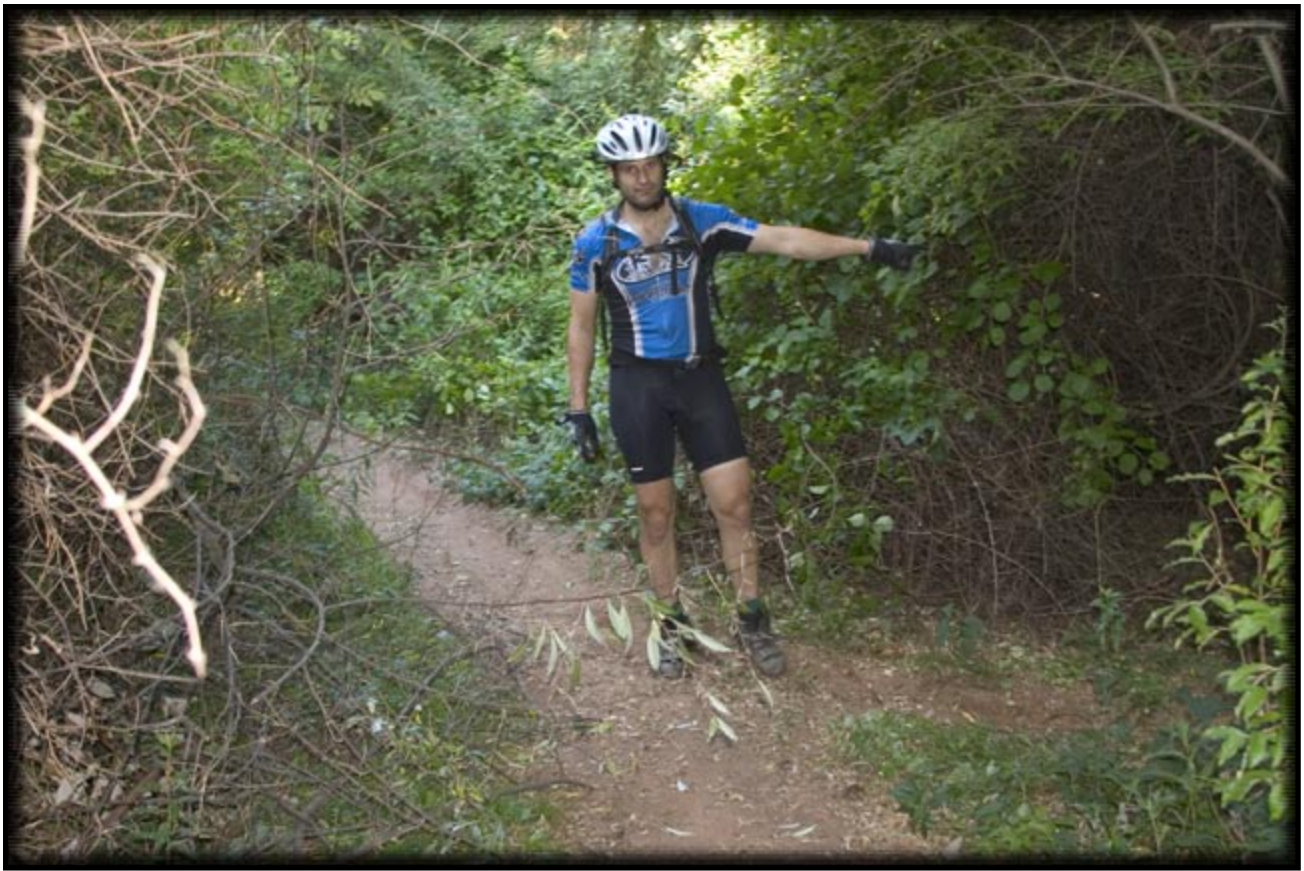
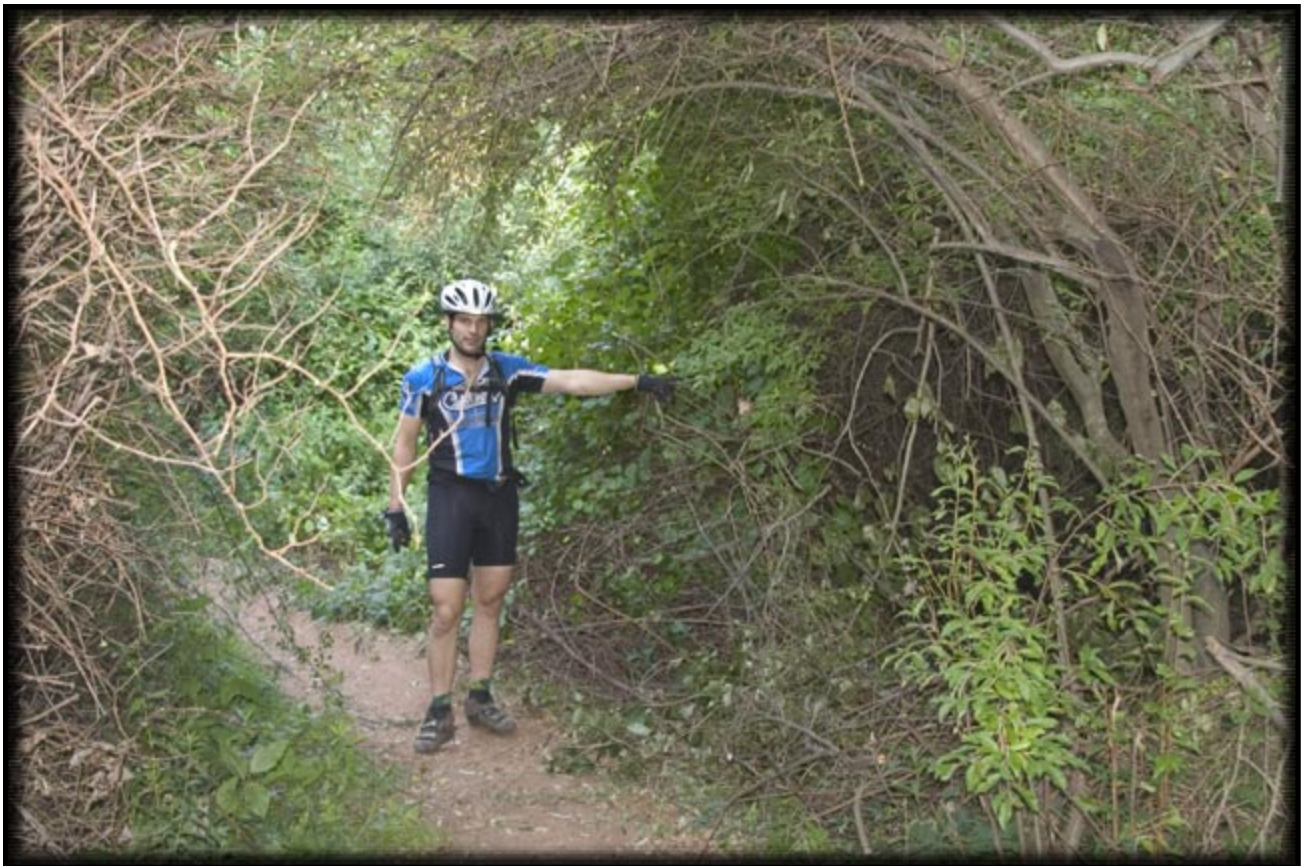
figure #5a

5. This trail was closed. (see figure #s 5a & 5b)

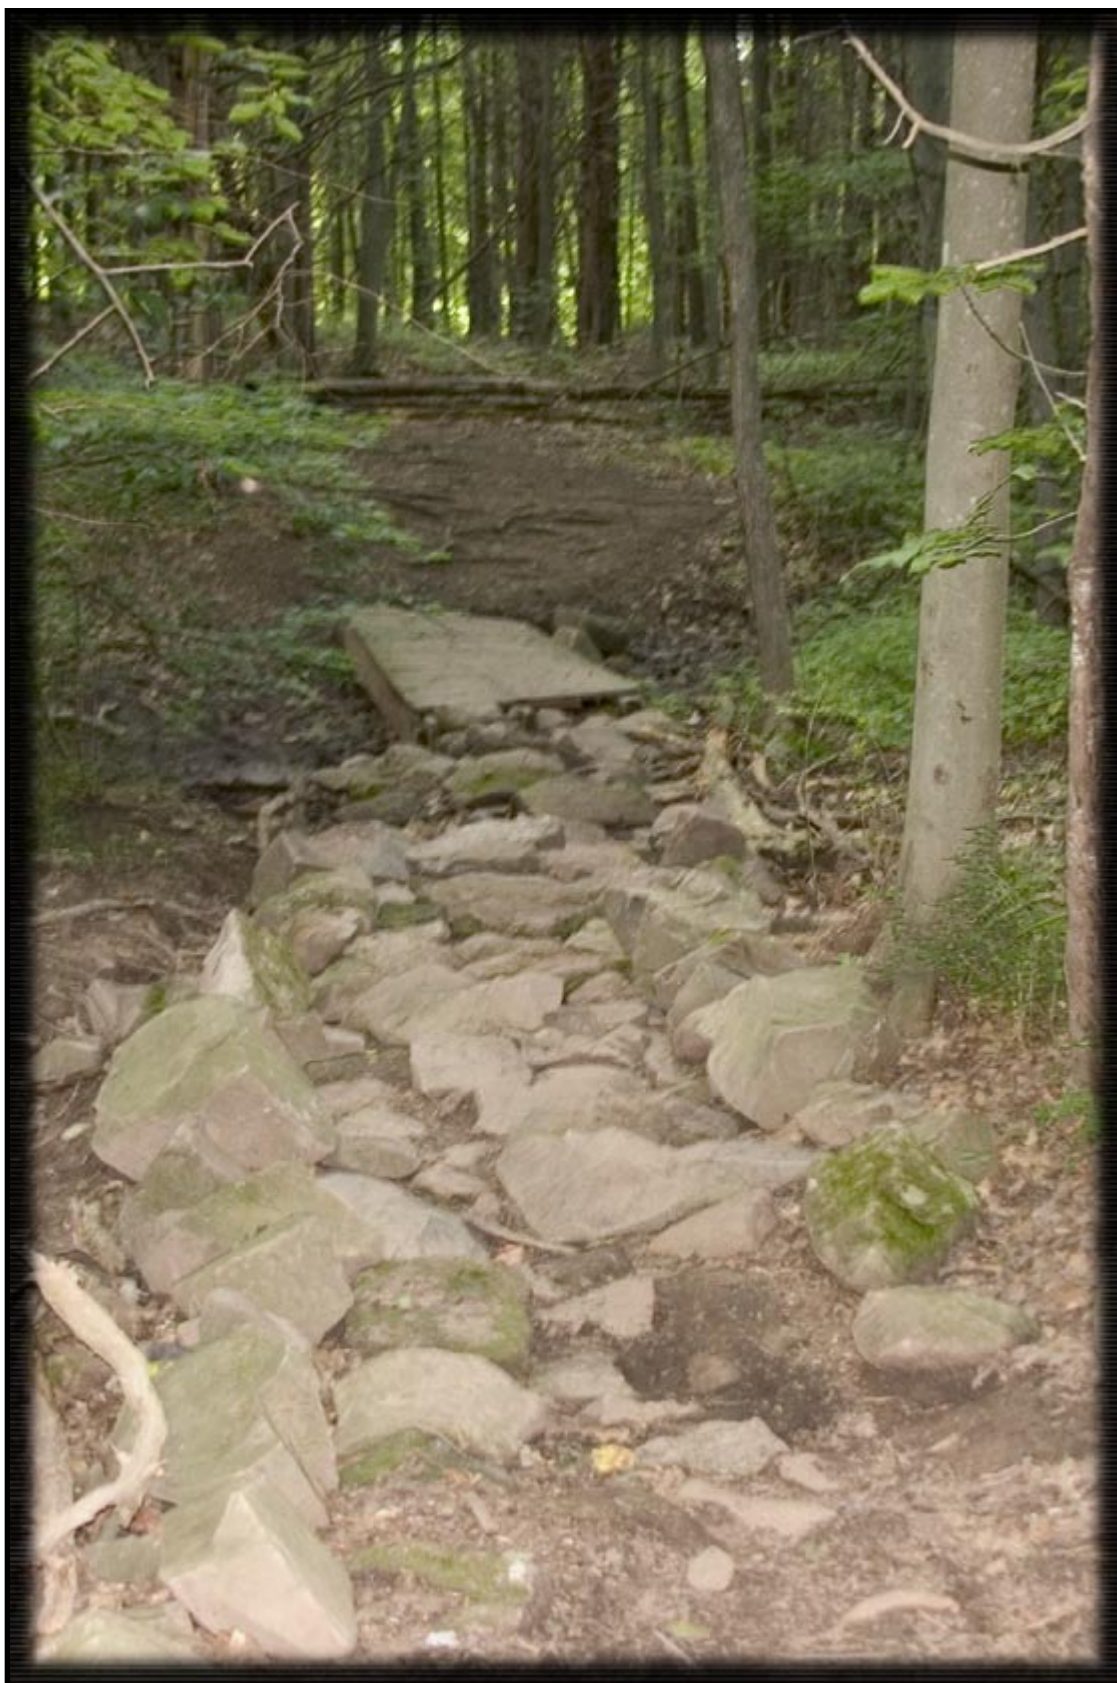
figure #8a

8. Another example of trail armoring. (see figure #8a)

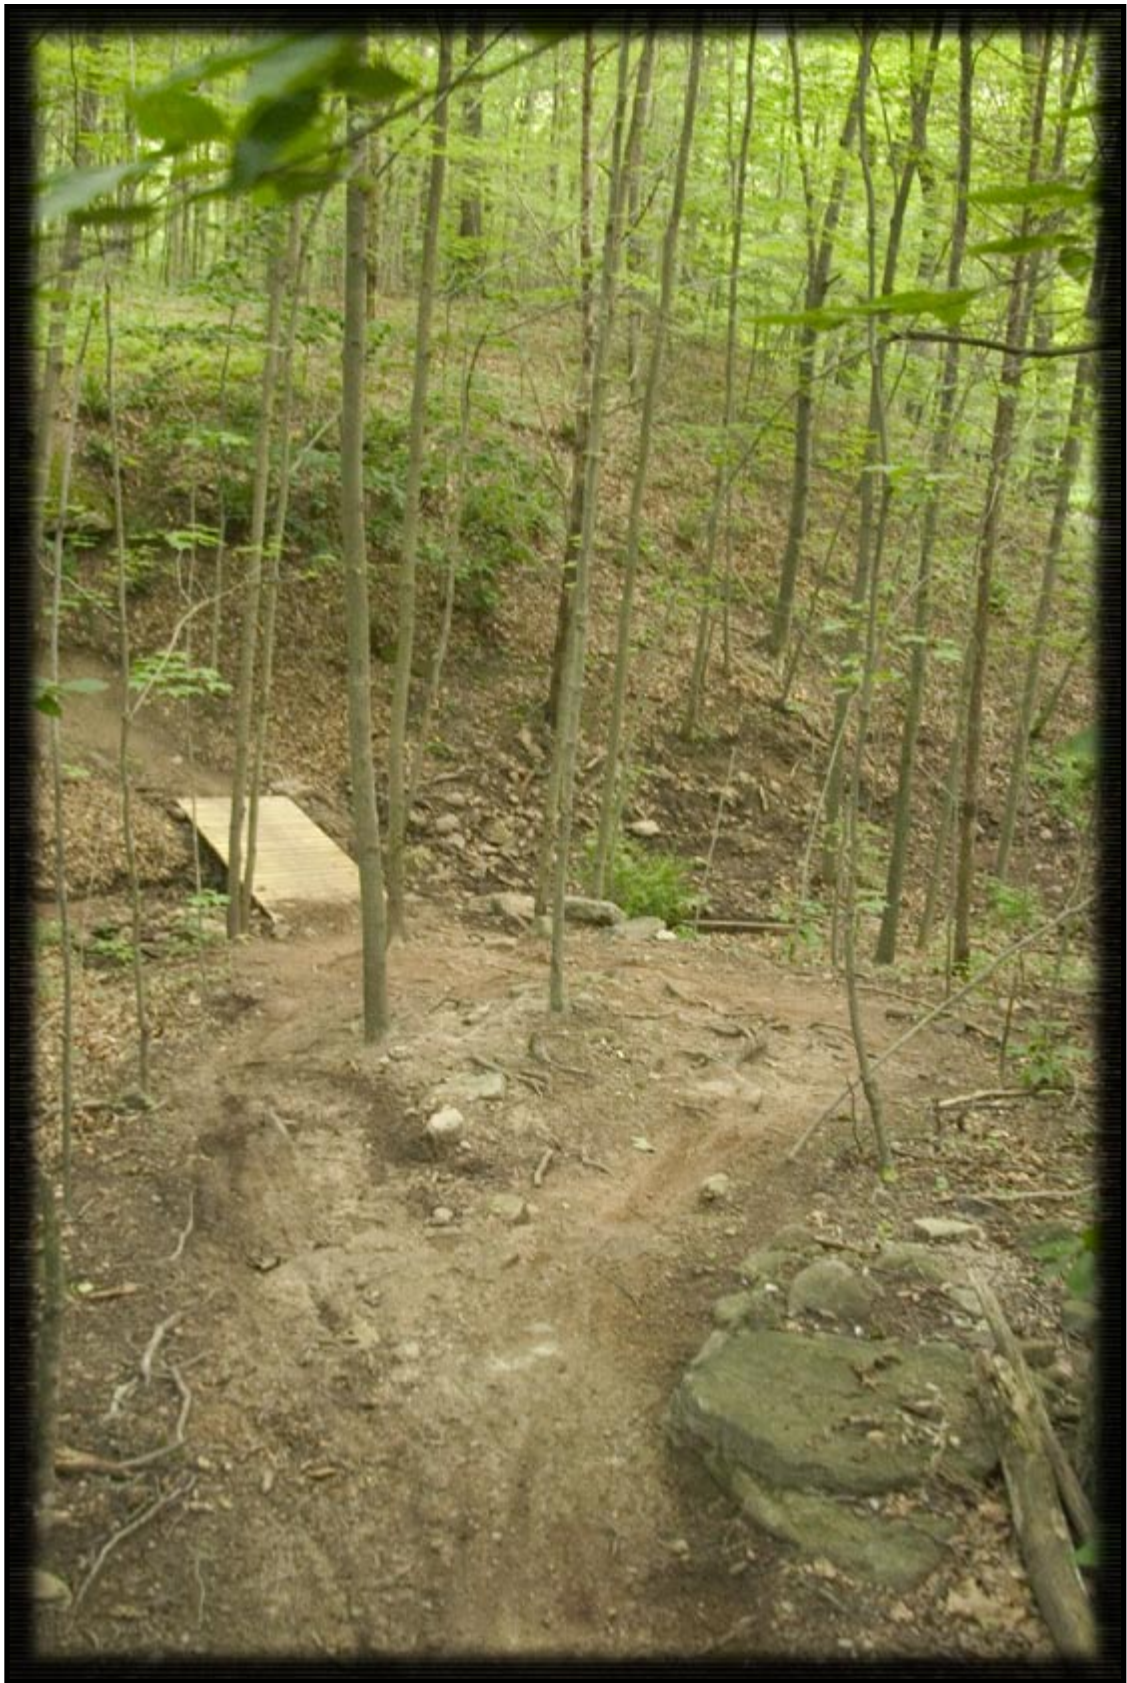
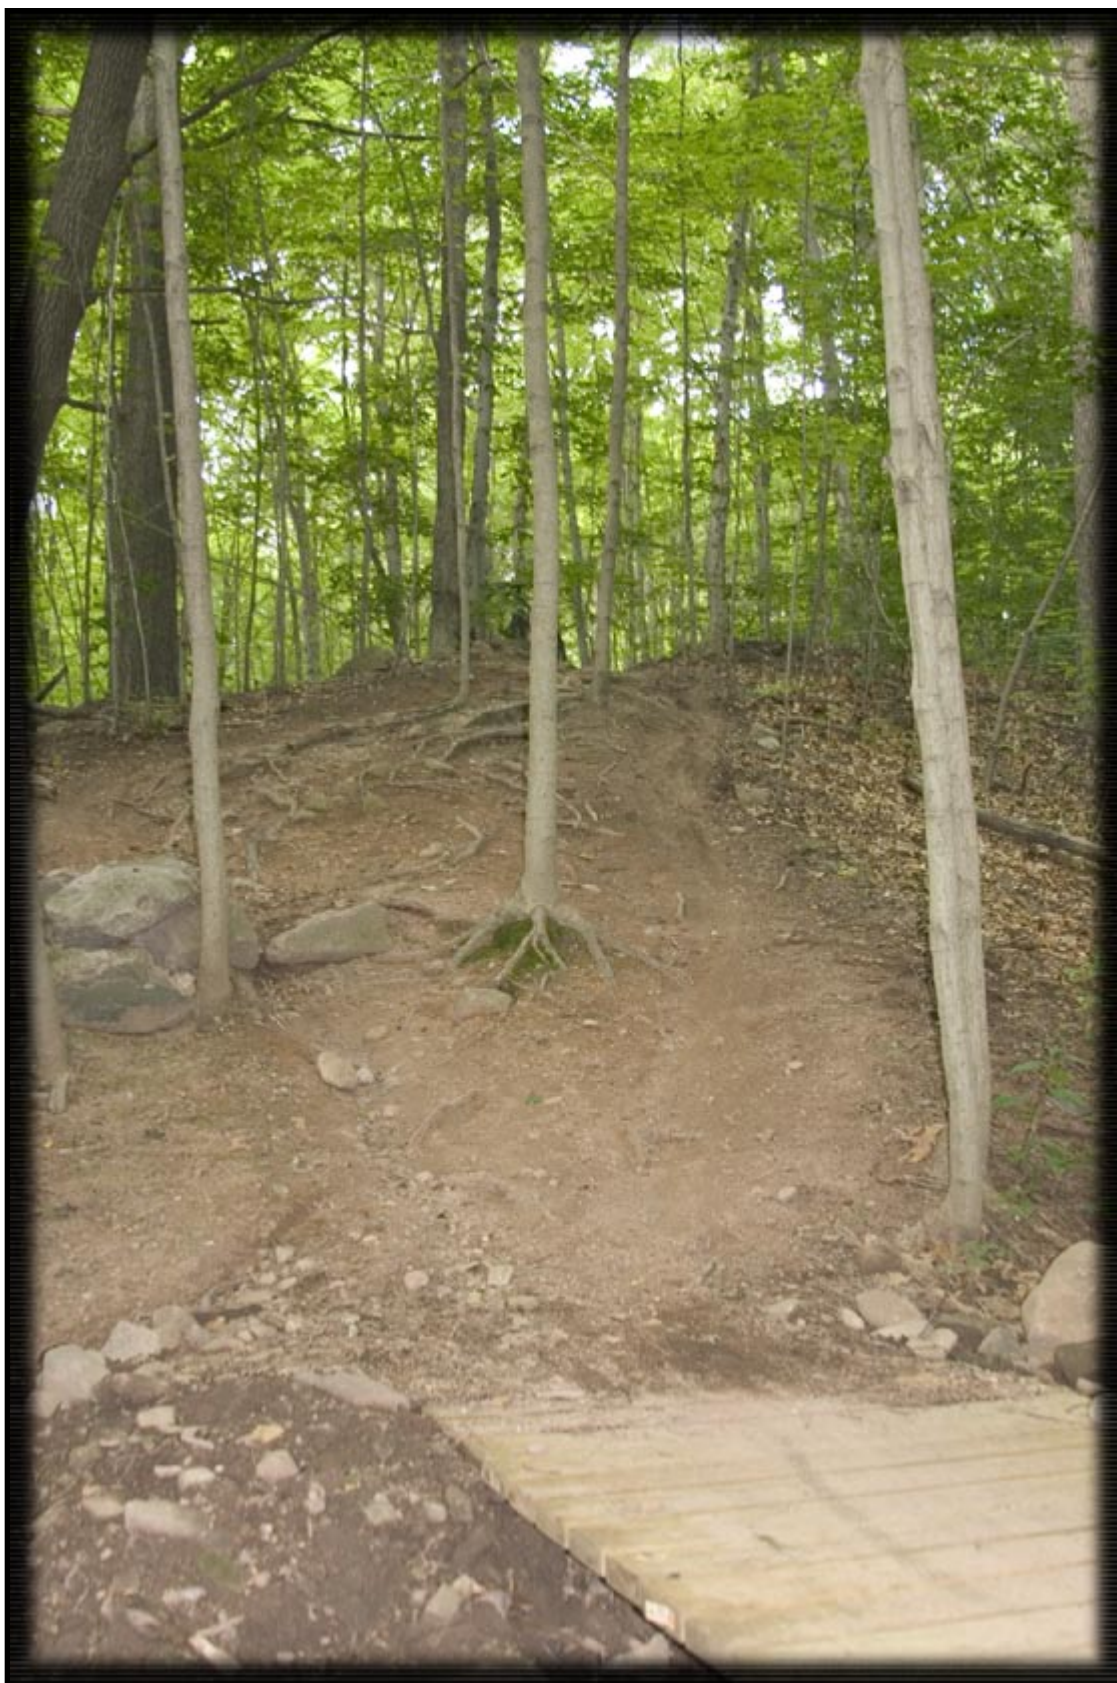
figure #9a

9. This area was originally rerouted in 2001 by the New England Mountain Bike Association during a trail work . However, a group of individuals who resisted trail improvements did not support the reroute. We work hard to persuade other users to support maintenance towards a sustainable trail system at Tyler Mill. This original trail is far too steep and any run-off from the trail goes immediately into the seasonal stream. The 2001 reroute will be revived as time allows. (see figure #s 9a & 9b)

10. This was a new bridge built by Public Works at our bequest. We are very happy with this bridge since it is functional, strong and aesthetically pleasing. (see figure #s9a & 9b)
