Wallingford

Mountain Bike Association

INTERIM REPORT 7-28-04

Trail Progress

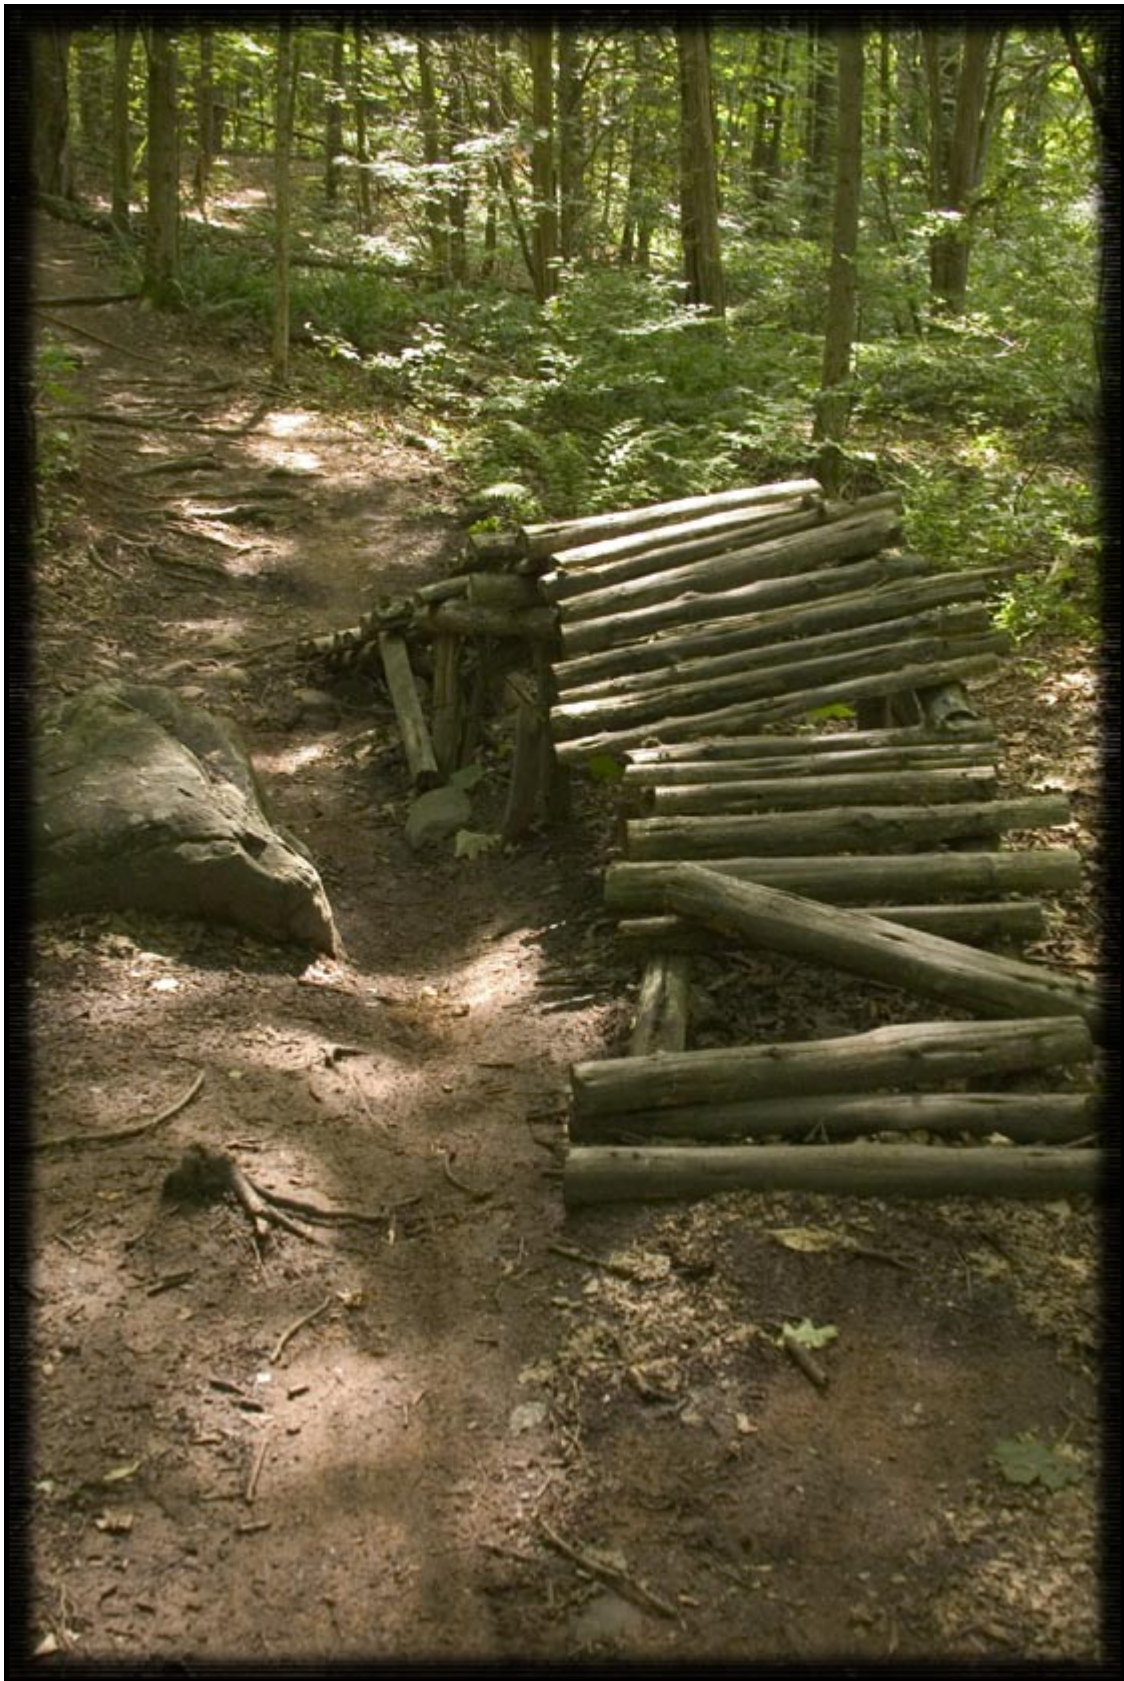
figure #15a

15. An original bridge was constructed here that was too difficult for many trail users to negotiate. Tires and footprints went into the streambed and it was decided after review with Henry McCully, the trail should be moved to higher ground, The old bridge be removed and a new one built in its place. This reroute was recently completed. It is possible to see the old route which also went up a steep hill which led to far too much erosion. The new route includes a bridge that is easier to negotiate and avoid the steep hill climb. (see *figure #s 15a, 15b, 15c*)
